The Ultimate Safety Guide for Solar PV Connectors

An In-Depth Primer with Best Practices for Solar Professionals and Asset Owners

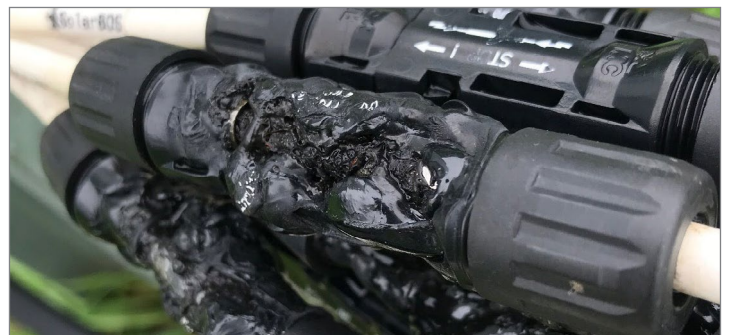
Burnt and melted connectors at an operating project.

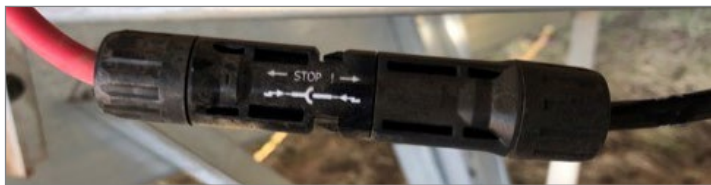
A mismatched MC4 and MC4-compatible connector in the field at a site with extensive connector failures.

Do not allow cross-mated connectors unless they are tested and certified together as a single component. Obtain new connectors from module manufacturers if necessary.

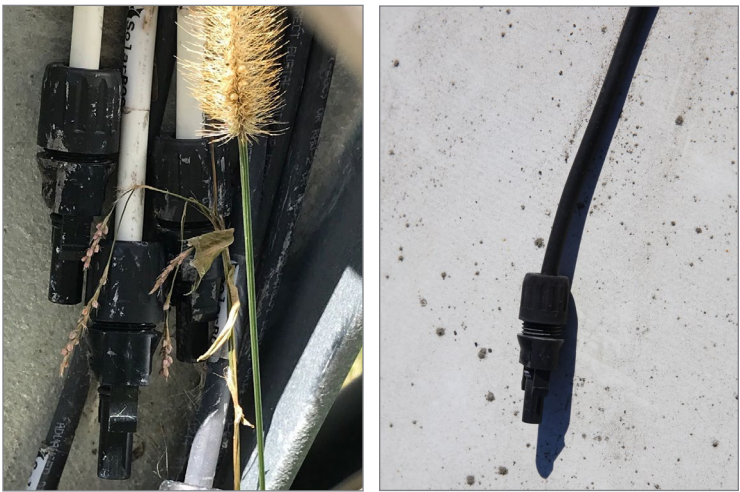
Connectors that are left unplugged and uncapped during construction are often exposed to moisture and foreign particulates, such as dirt or other organic matter. Without connector caps, the metal pins of the connectors will be exposed to moisture and begin to corrode.

Then, once the connector is closed, the corrosion continues to propagate, increasing connector resistance until the connection eventually fails. **These connectors can become time bombs waiting to ignite to the field.**

The connectors above are examples of potential time bombs: they were left unplugged without end caps at a utility-scale plant (left) and a commercial rooftop system (right).

Use manufacturer-provided crimping tools. String modules immediately to prevent environmental exposure and use end caps when necessary. Document the status and location of all field-made connectors at the time of installation.

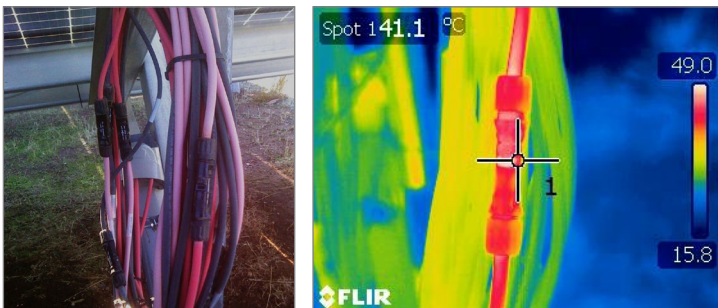
The images above show differential temperature failures. One of the connectors in the bundle (left) has an operating temperature that is 15°C higher than the others, as indicated by the thermal image (right).

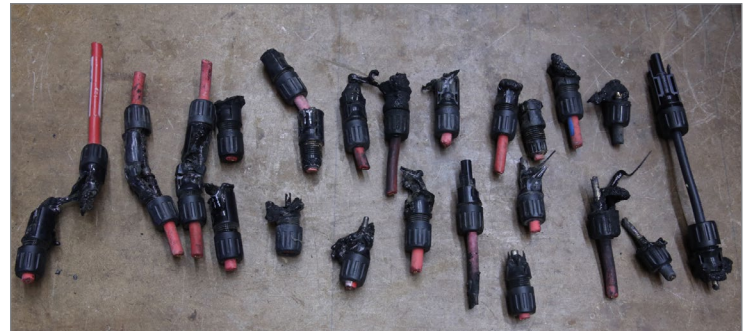
The sample of failed connectors above melted due to high temperature operation in the field. PVEL removed the devices from the field for testing and root cause failure analysis.

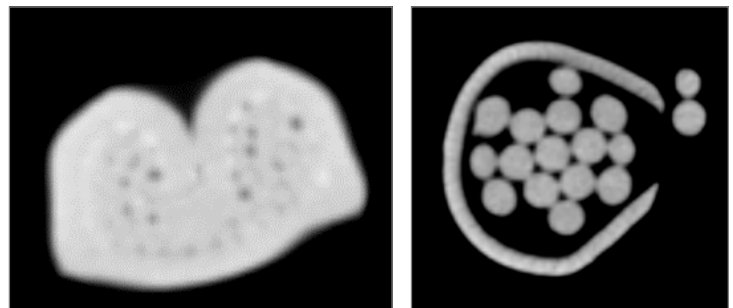
The above XCT cross-section images show the difference between a correct (left) and poor (right) connector crimp found by PVEL in an active PV installation.

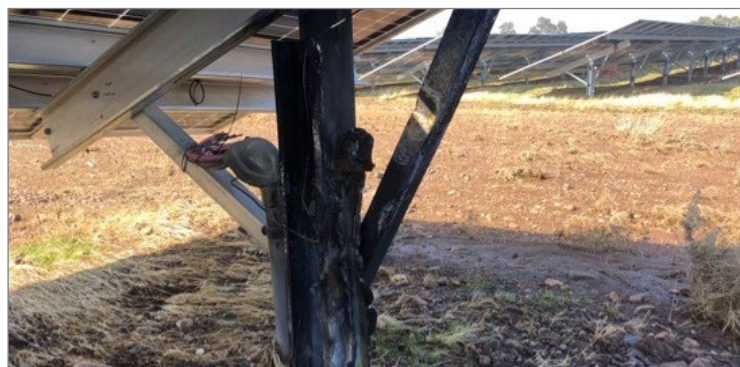
A single overheated connector caused this catastrophic failure. Per PVEL's testing, installation error is likely the root cause.

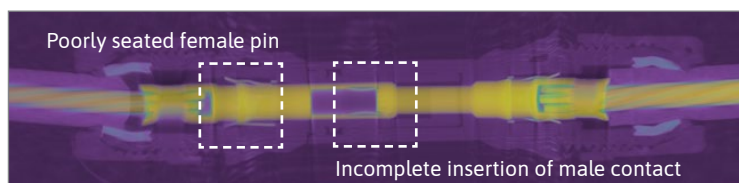
These XCT images show two poorly installed connectors. The top image reveals incomplete insertion and the left image zooms in on a channel for water ingress due to an undertightened nut.
