TENSILE IMPACT EXPERIMENTS OF PVC-U AT A WIDE RANGE OF TEMPERATURES

J. Weller, E.J.W. van der Stok, R.J.M. Hermkens

Plastic Pipes XVI Conference – Barcelona, Spain, September 24-26, 2012

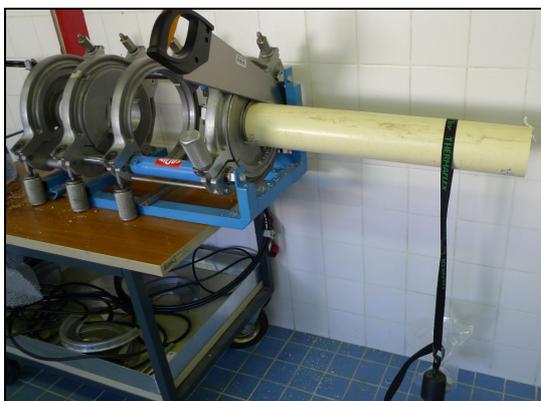
Figure 13: The saw-test performed on a PVC-U pipe

In this test one end of the PVC pipe is clamped to simulate solid soil. The protruding section is then subjected to a bending moment of 17.6 Nm by suspending a weight from the pipe at a fixed distance. A simple crosscut handsaw is then used to cut the pipe. The experiments are performed at 20°C (± 2°C) and in a climate chamber at +5°C (±0,5°C). Two sawing speeds are used: slow and rough.

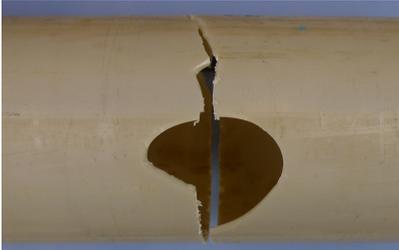
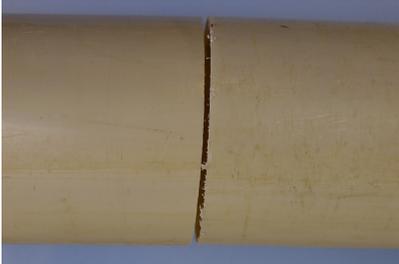
Test pipe A	5°C	20°C
Rough sawing

Brittle crack

No crack
Slow sawing

No crack

Pipe A shows better material properties and only cracks when, at low temperatures, the sawing is done rather roughly. This also confirms the information found in figure 8. The PVC-U material clearly has ductile behaviour and it also performs a lot better in the saw-test.

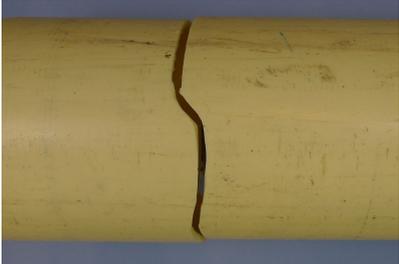
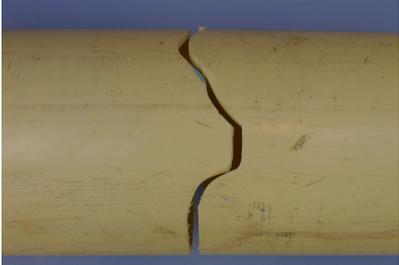
Test pipe B	5°C	20°C
Rough sawing

Brittle crack

Brittle crack
Slow sawing

No crack

Pipe B is very brittle and only sawing it slowly at 20°C prevents it from cracking. This confirms the conclusion which was drawn after reviewing figure 11: this PVC pipe has very poor material properties.
