# **PVC PIPES IN GAS DISTRIBUTION: STILL GOING STRONG!**

**René Hermkens \***, **Mannes Wolters \* #**, **Jeroen Weller \***, **Roy Visser #**

\* Kiwa Gas Technology, Apeldoorn, The Netherlands

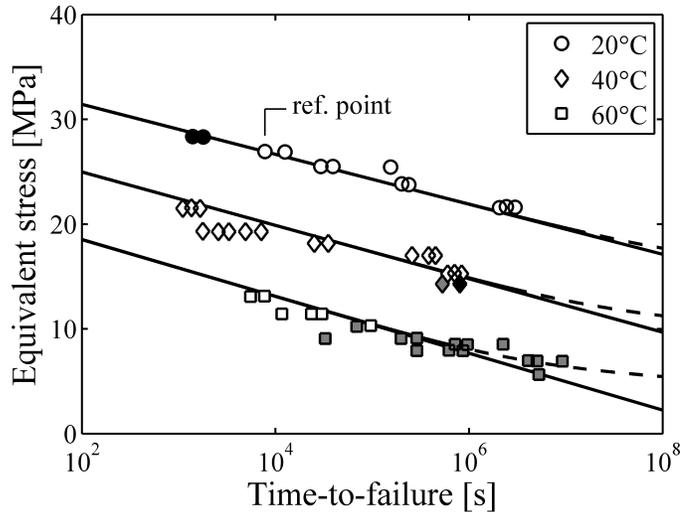
Typical results of burst tests on rigid PVC pipes are shown in figure 1 (data taken from (2)). The predictions of the model are presented with solid and dashed lines. The solid lines represent prediction for the failure time without taking the effect of physical ageing into account. Both the slope and the temperature shift are predicted correctly. The predictions which are presented in dashed lines take physical ageing into account, causing the failure

Figure 1. Failure time for uPVC pipes under internal pressure, taken from (2). The model predictions without ageing and with ageing are shown with a solid and dashed lines, respectively.

times to increase at low applied stresses and long failure times. This is a result of an increase in resistance against plastic deformation due to physical ageing. The first extensive study on this relation between physical ageing and deformation behaviour was carried out by Struik (4).

The internal pressure in rigid PVC pipes which are used for the distribution of gas is maximally only 100 mbar. At this pressure, the equivalent stress in a common pipe with a diameter of 110 mm and a wall thickness of 2.7 mm is only about 0.1 MPa. At this stress the model predicts failure after  $5 \cdot 10^{156}$  years (virtually eternity) at 10°C, which is not a big surprise for such a low pressure. It is therefore a safe conclusion to state that failure due to the internal pressure will not be the limiting factor for the lifetime of a rigid PVC gas pipe.

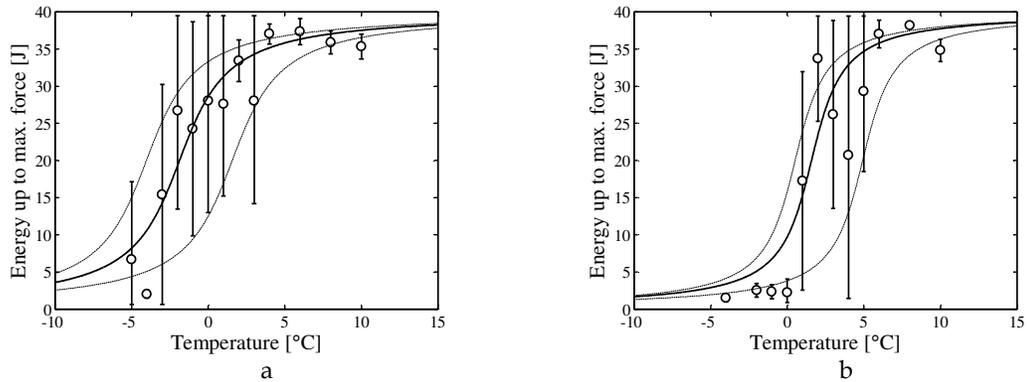
Figure 2. Ductile-to-brittle transition temperature for as received (a) and aged (b) rigid PVC pipe

The energy up to the maximum force is plotted versus the temperature in figure 2. The lines are guides for the eye for the mean energy up to maximum force (solid lines) and the upper and lower limits (dashed lines). The energy up to the maximum is a measure for the amount of impact energy a rigid PVC sample can resist before it fails. This impact resistance versus temperature is plotted for samples that did not receive a heat treatment (subplot 2a) and for aged samples which did receive a heat treatment (34 days at 60°C, subplot 2b). The ductile behaviour can be found at higher temperature in both figures, while the brittle fractures are observed at lower temperatures. As expected, a clear difference between the energy up to the maximum force is observed between the brittle and the ductile failures. The transition from ductile to brittle behaviour is located just below 0°C for the as received specimen, whereas for aged specimen this transition temperature seems to be at a somewhat higher temperature (around 2°C). The existence of this shift cannot be significantly determined with the current measurements. A plausible explanation for the small difference in impact behaviour between the as received and the aged samples is that the as received samples might already had a significant initial age. In that case, the resulting age of the additional heat treatment might just differ one or two orders of magnitude from the initial age. As physical ageing occurs on a logarithmic timescale these differences do not result in a considerable change in impact behaviour. In future work the same tests will be repeated on specimens with a lower initial age to get a clearer image of the influence of physical ageing in the shift of transition temperature.

- Physical ageing, and thus the change in impact behaviour, occurs on a logarithmic timescale. This means that differences are more distinct at a low age.
- The shift of the transition temperature between the as received and the aged samples seems to be a minimal and not of great importance. However, this shift can be of importance due to the location of the transition temperature. Generally, excavations are carried out at temperatures down to 0°C. A transition temperature below 0°C means that in most cases ductile failures will be encountered if a pipe is hit. Transition temperatures above 0°C increase the risk on brittle behaviour.

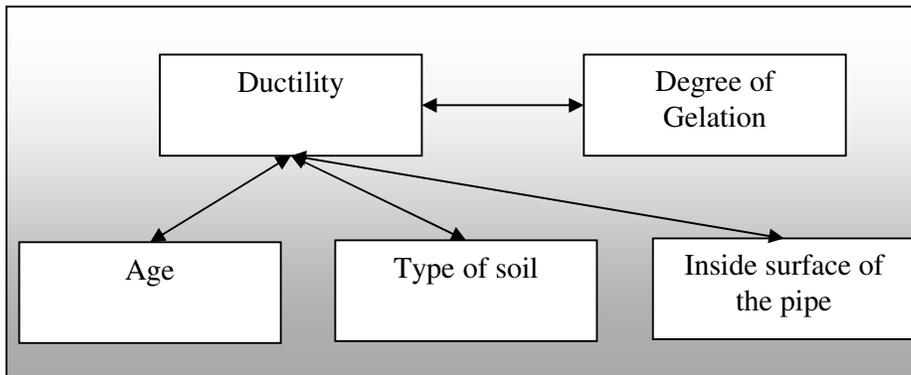
Several analyses have been performed. Ductility is presumed to be the main parameter in the determination of the pipe quality for the use of gas pipes in low pressure systems. The most interesting types of analyses are presented in figure 3.

*Figure 3. Analyses performed in this study*

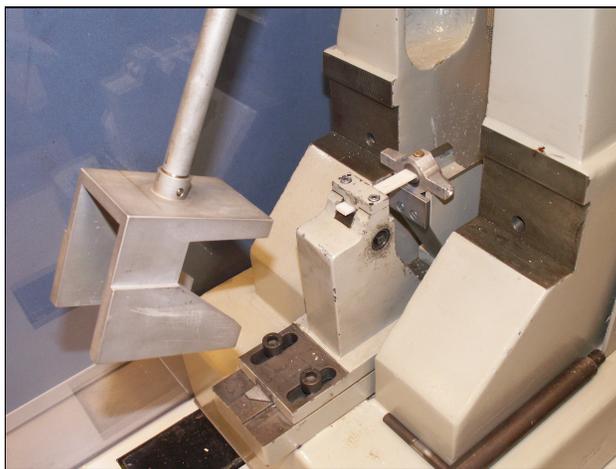
During the past 4 years a total of 86 samples have been excavated and tested. In this study the ductility (or impact resistance) of the rigid PVC pipes was measured using a pendulum tensile impact tester. (see Picture 1). Prior to impact testing the excavated samples have been inspected visually.

*Picture 1 Pendulum tensile impact test machine*

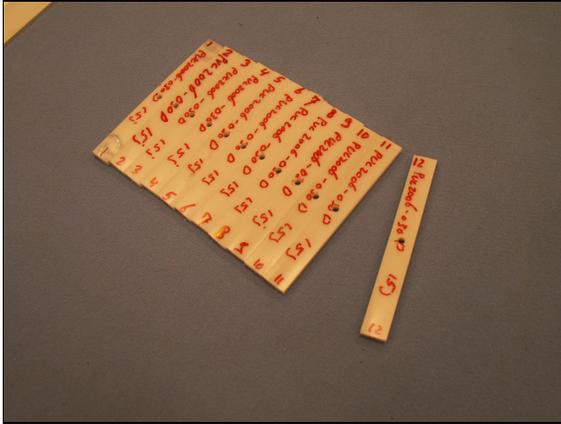
Special care was given to changes in the smoothness of the surface (both in- and outside). To make impact testing possible 12 test bars were processed out of the excavated samples.(picture 2). While processing special care was given to prevent the sample from heating, since this heating could locally induce additional unwanted physical ageing. Of each sample 10 test bars were tested.

Picture 2. Prepared test bars for tensile impact testing.

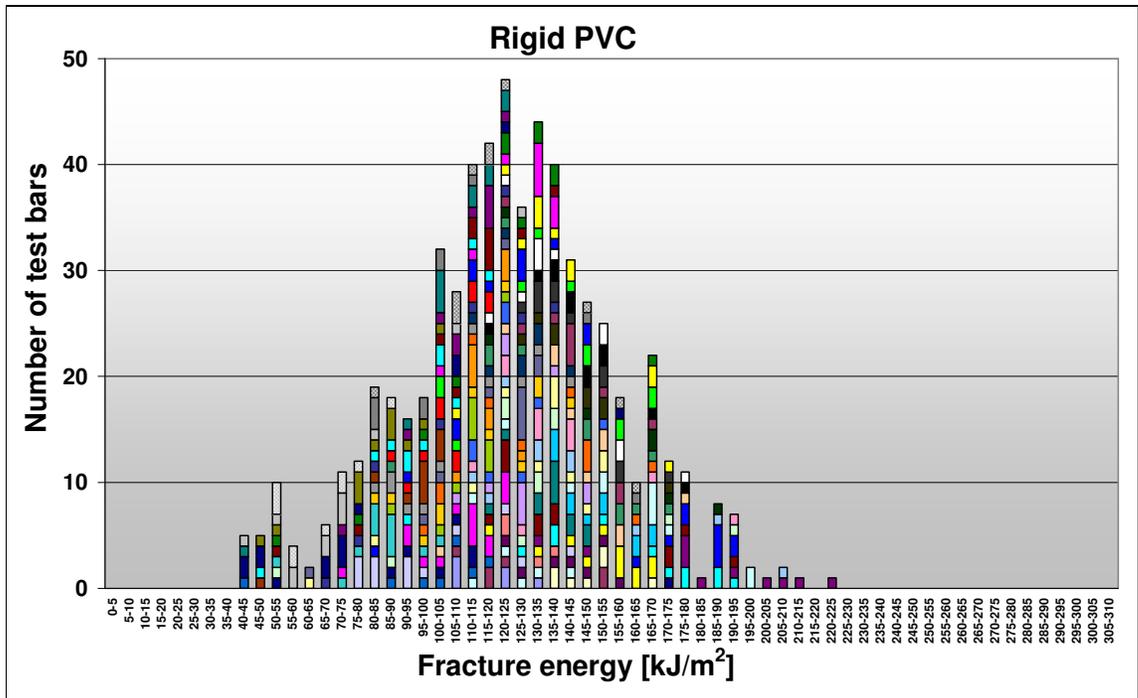
Since failure in practice is often caused by the lack of ductility, ductility is used as an indicator for mechanical quality. In figure 4 the histogram shows the results of all individual test bars. Statistical analysis of the data, using the software tool SPSS, shows that the results of the tensile impact tests are normally distributed. The mean value of the distribution is  $127.3 \text{ kJ/m}^2$ . The standard deviation is  $23.2 \text{ kJ/m}^2$ .

Figure 4. Histogram of tensile impact results

The fact that we are dealing with a normal distribution makes analyses using this data easier. Analyses of possible correlations between the results of the tensile impact tests and all other parameters have been performed using SPSS (version 16) as well. In some cases the numbers of test results were insufficient to carry out a proper analysis.

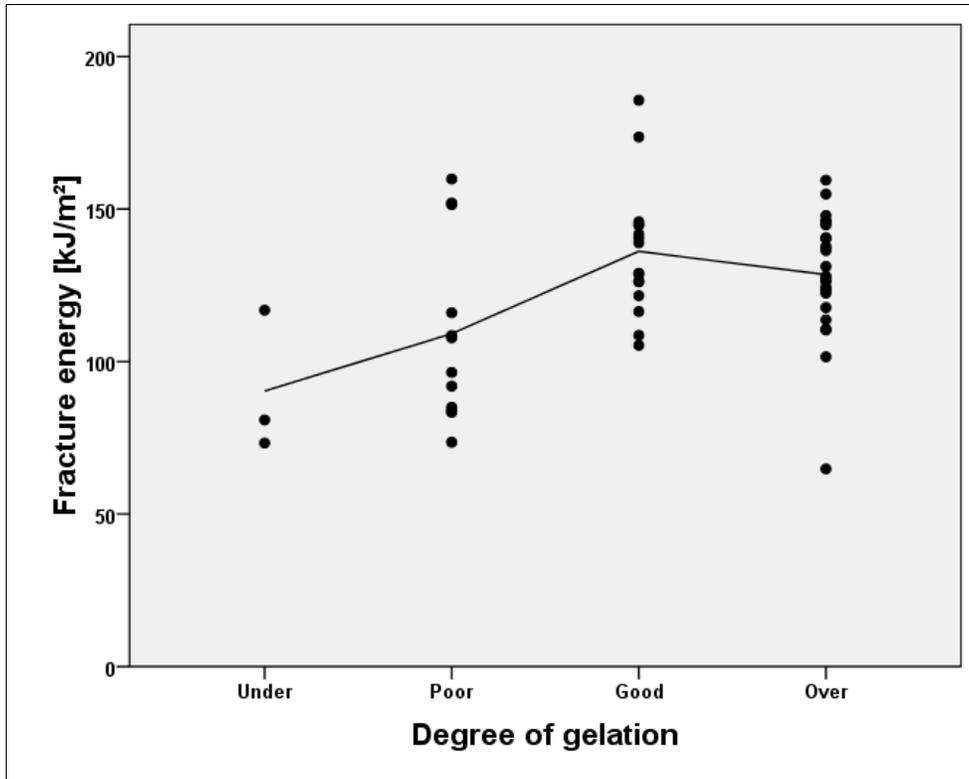
The results seem to be in agreement with earlier work (5) that shows an optimum of mechanical quality for rigid PVC materials. In spite of the scatter shown in figure 5, statistical analysis shows a significant difference between “good” degree of gelation and “under”, “poor” and “over” degree of gelation. Based on this analysis properly produced rigid PVC pipes having a good degree of gelation show a higher resistance to impact compared to ones that have been produced in a less proper way.

Figure 5. Quality (ductility) as function of the degree of gelation

- The relation between the mechanical quality (impact resistance) and the degree of gelation shows an optimum quality in terms of impact resistance for the pipes where the degree of gelation can be classified with “good”. This relation is in agreement with comparable tests results obtained in the early seventies. (5) In this study there was also a maximum mechanical quality found for good produced pipes. This similarity shows that even after 50 years of practice the impact resistance is still dependant on the initial quality fixed during the production of the pipe.

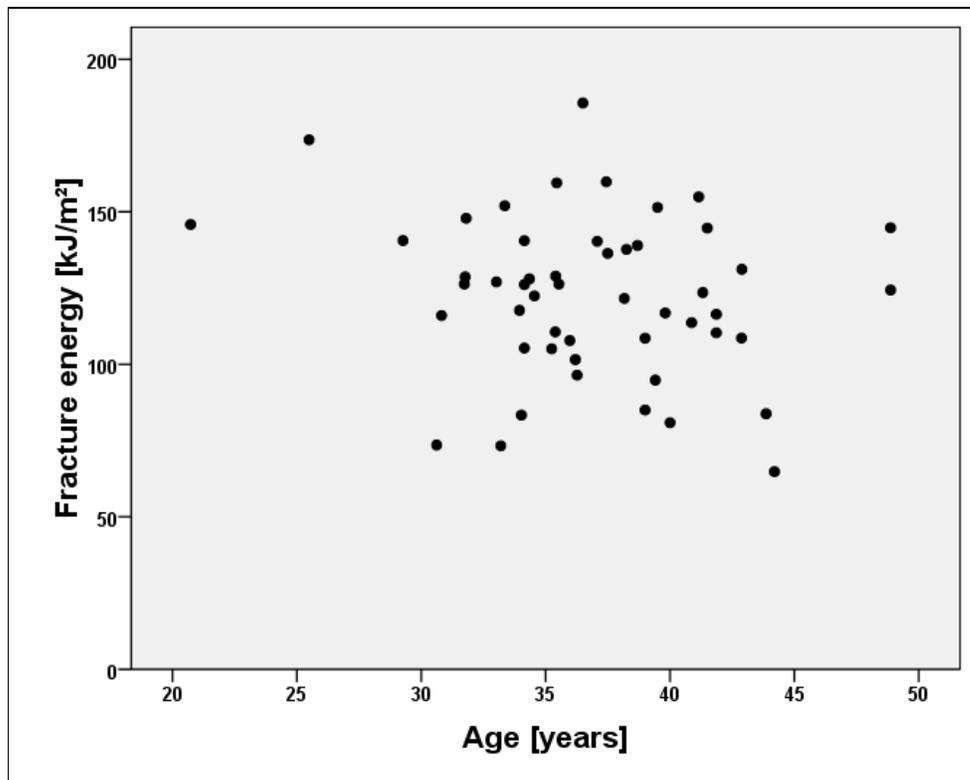
The results of the tensile impact tests as a function of the age of the pipes are shown in figure 6. This figure shows a lot of scatter. In this case age is equal to the time the pipes have been installed under ground. Although it is expected, no indication has been found that could confirm the pipes to show any degradation. The resistance to impact is as we have seen already dependent on the degree of gelation, which is fixed at the time the pipe is produced. While the scatter between the degree of gelation of the complete population is rather high an effect of reduction of the ductility might be present, but cannot be seen at all. The number of samples however is too limited to analyse the same relation for pipe produced with a “good” degree of gelation.

Figure 6. Quality (ductility) as function of the age of the pipes

- The relation between impact resistance and the age of the pipes is also investigated. Since the scatter in the test results is high, no relation between impact resistance and age of the pipe can be found. While ageing is known to reduce the impact resistance of rigid PVC pipes, no evidence for reduction of the ductility can be seen for these low pressured buried gas pipes. This is in agreement with the conclusion drawn from the brittle-to-ductile temperature transition study.
